YOUR INSPECTION REPORT

1234 Main St. Forney TX 75126

PROPERTY INSPECTION REPORT

Concerning: 1234 Main St. Forney TX 75126
(Address or Other Identification of Inspected Property)

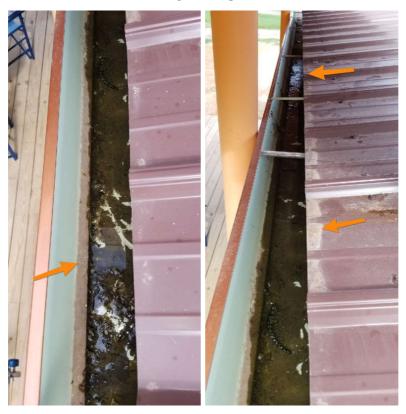
2: Improper slope

slope on gutter is slanted in away that will cause poor drainage. There is standing water in gutter, meaning it is not flowing towards down spout. Recommend adjusting slope.

Recommendation: Contact a qualified gutter contractor

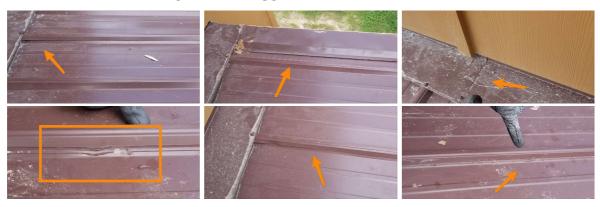
1: Sealant Needed

All connections / seams should be sealed to prevent water intrusion into home.

Recommendation: Contact a qualified roofing professional.

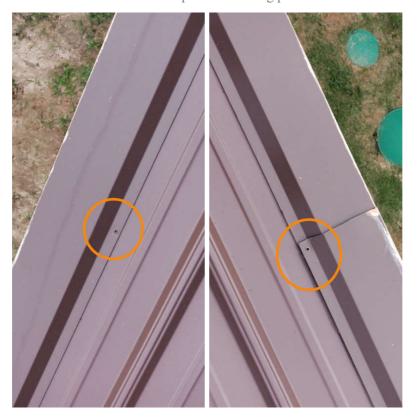
2: Missing Fasteners

Metal roof is missing self sealing fasteners.

Recommendation: Contact a qualified roofing professional.

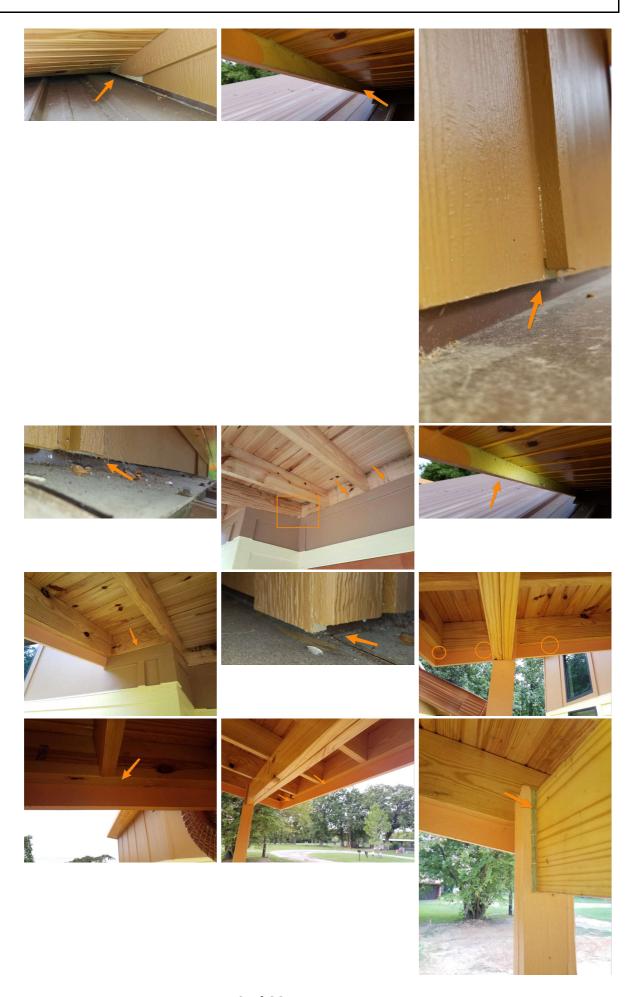
1: Paint or Stained Recommended

All exposed wood should be painted or stained. Exposed wood will absorb moisture and damage much sooner than painted or stained wood.

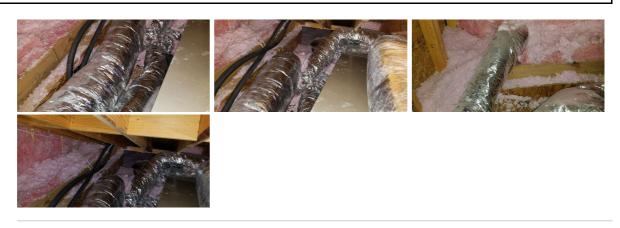
1: Duct on floor

The flexible air ducts are improperly installed, They are laying on the attic floor. Air ducts should be suspended from the over head and supported every 4 feet, with no more than 2 inches of sag between each supporting strap.

Recommendation: Contact a qualified professional.

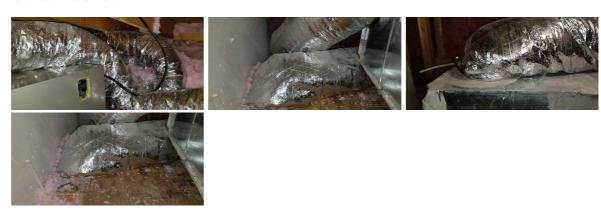
2: Restriction of flow

Duct work is turn too sharp restricting the flow to the room this can cause a pressure difference and a temperature difference in that room. Recommend be adjusting the straps holding the ductwork in place to allow more flow

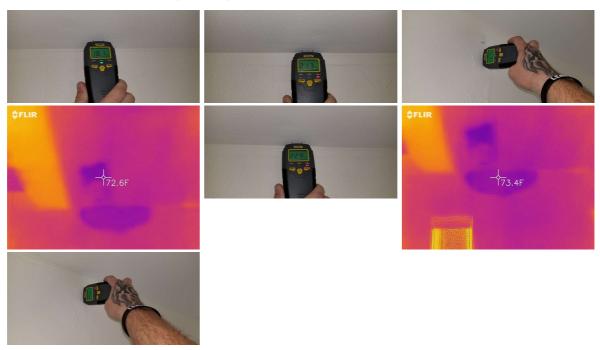
1: High moisture readings

High moisture readings (above 20%)

Recommendation: Contact a qualified professional.

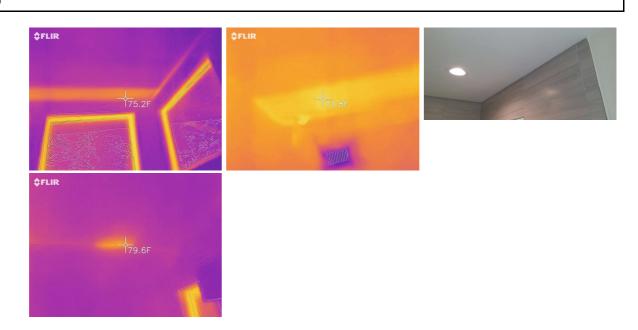
2: Missing insulation

The thermal images below represent missing insulation. This can easily be fixed. But until fixed may reduce efficiency in the area of missing insulation.

In the case of doors, insulation reefers to door seals and or gaskets.

Recommendation: Contact a qualified professional.
