YOUR INSPECTION REPORT

1234 Main St.
Forney TX 75126

PROPERTY INSPECTION REPORT

Concerning: 1234 Main St. Forney TX 75126
(Address or Other Identification of Inspected Property)

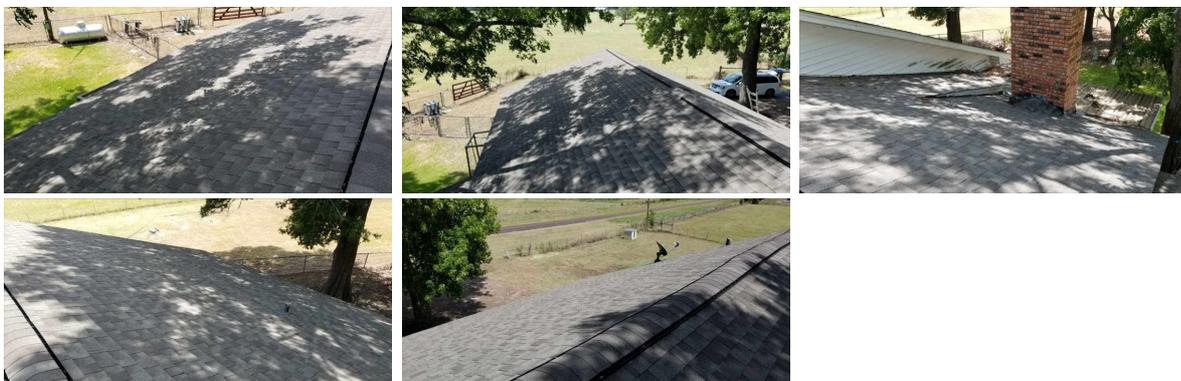
1: Damaged Coverings

Roof coverings exhibited damage and or granule loss that could affect performance. Recommend a qualified roofer evaluate and repair.

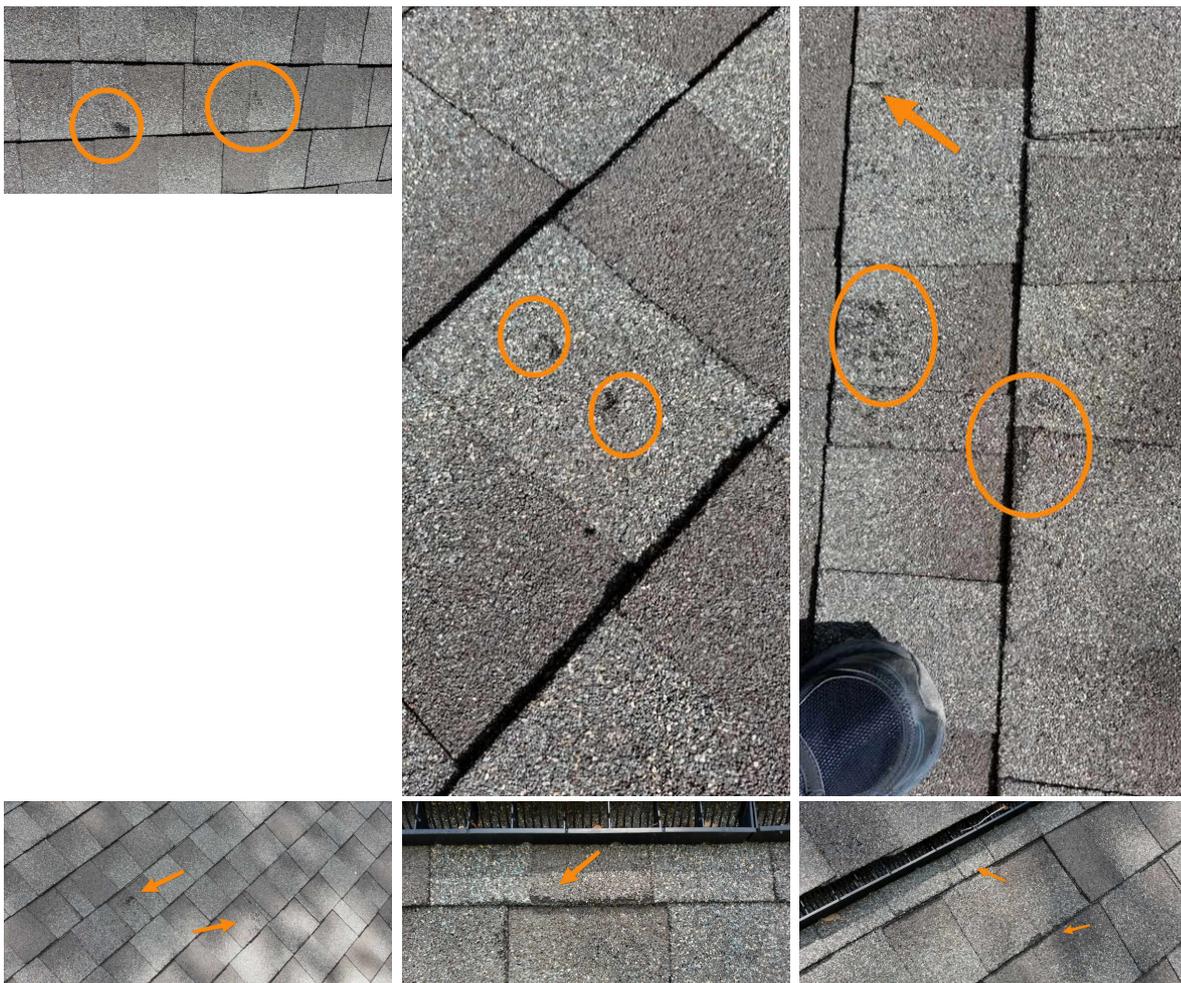
2: Flashing In Need Of Maintenance

Flashing around roof structure in need of paint and or sealant.

Recommendation: Contact a qualified roofing professional.

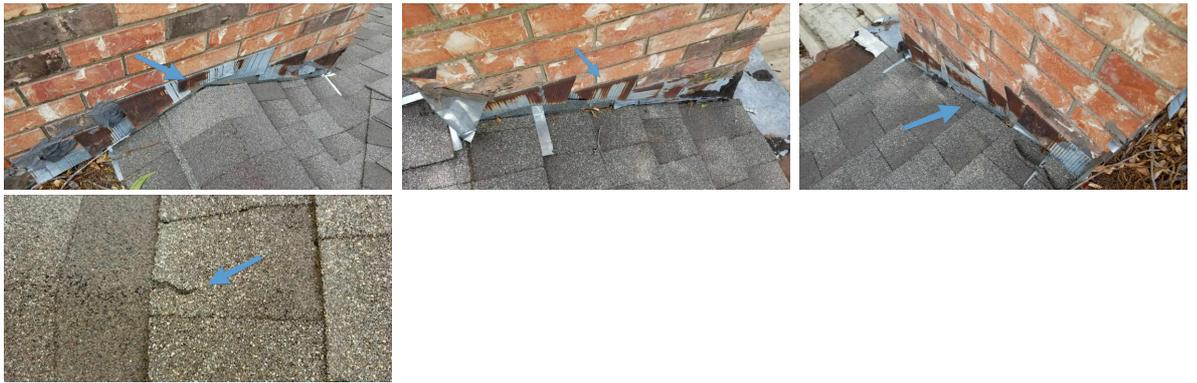
3: Torn Shingles

Shingle torn, should be repaired or replaced.

Recommendation: Contact a qualified roofing professional.

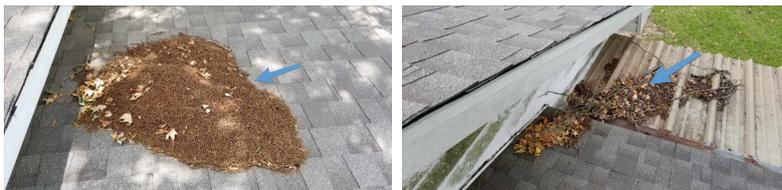
4: Debris

Debris on roof, it's recommend to keep roof clear of debris to prevent damage to roof coverings

Recommendation: Contact a handyman or DIY project

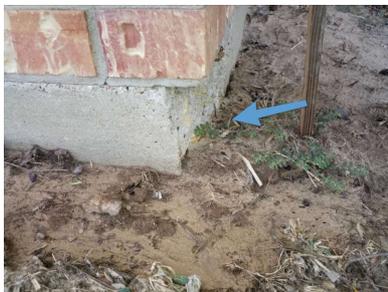
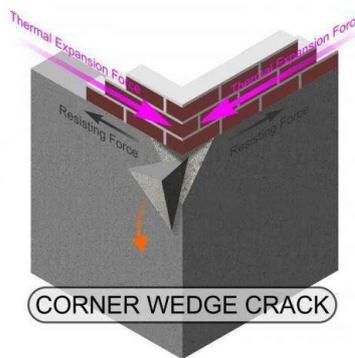
1: Corner Popping

Corner Popping also called a **Corner Wedge Crack**. **Corner Popping** of a foundation is considered a cosmetic, non structural issue

Brick expands due to thermal expansion and due to water absorption. A slab foundation is mostly underground and has much less exposure and is less porous than the brick, therefore making it much less expansive.

Recommendation: Recommend monitoring.

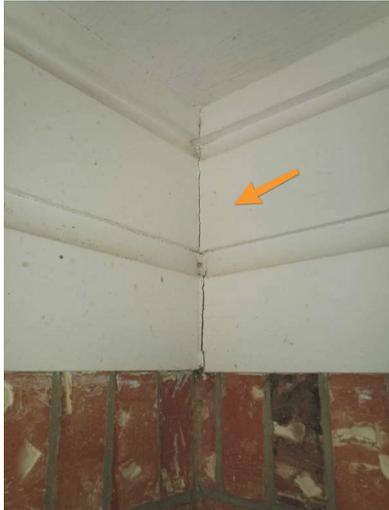
2: Foundation Settling/ movement

The property show signs of movement. siding and or trim has come partially detached from property. Parts of the floor are uneven further evaluation is recommended.

Movement is common. Keeping water away from property, proper slope and gutter systems can dramatically improve further movement.

Recommendation: Contact a foundation contractor.

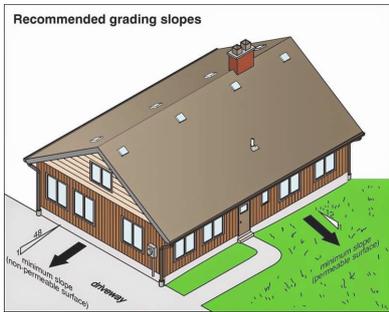
1: Negative Grading

Negative grading slopes toward your home, directing stormwater toward your foundation. When stormwater consistently collects near the home only bad things can happen. That is why we tell our customers and document that negative grading needs to be corrected.

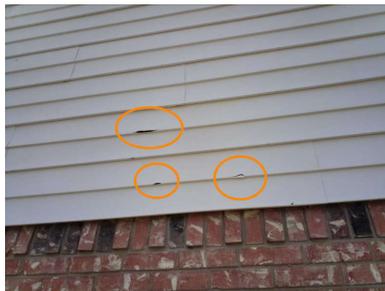
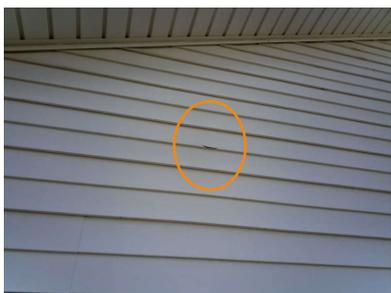
1: Siding In Need of Repair

Siding, has damage and gaps in various locations and should be repaired or replaced.

Recommendation: Contact a qualified siding specialist.

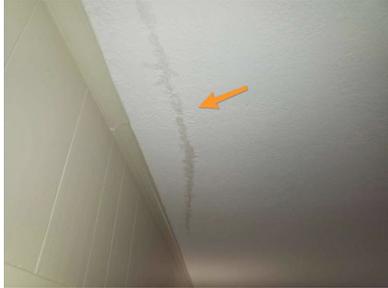
1: Ceiling - Minor Damage

Minor damage or cracks on the ceiling was visible at the time of the inspection.

Recommend patching or repairing damaged or cracked areas

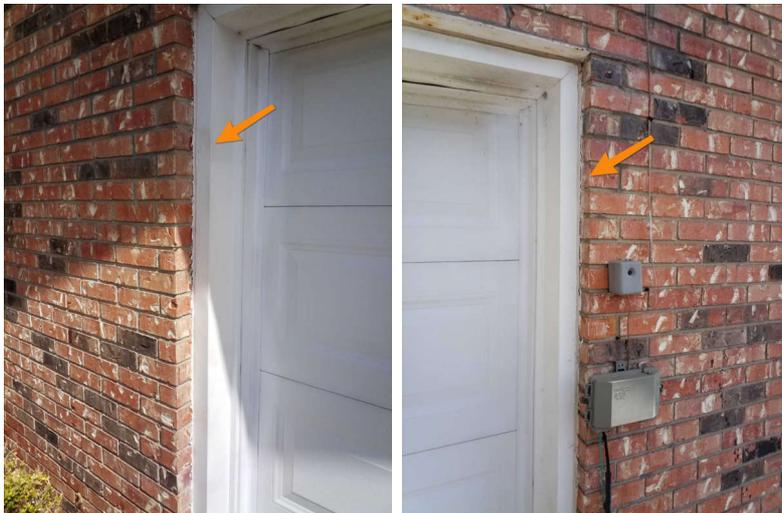
1: Sealant Recommend

Sealant on exterior trim around garage framing is in need of repair. Without proper sealant water and pest can cause damage to trim and property.

Recommendation: Contact a qualified professional.

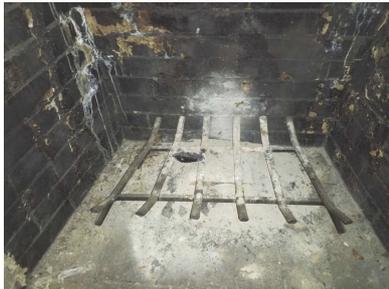
1: Chimney Liner Dirty

Chimney liner had layer of creosote dust, recommend cleaning prior to use.

Recommendation: Contact a qualified chimney sweep.

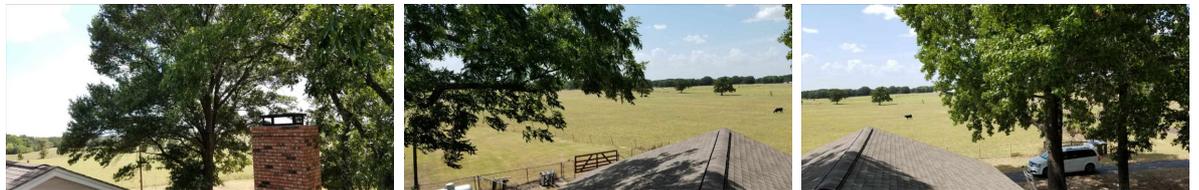
1: Tree overhang

OVERHANGING BRANCHES

Branches and limbs can easily break under the weight of snow/ Ice, or simply snap off in high winds. When this happens, the larger limbs can break or put holes in your roof, while smaller branches often rip off shingles as they fall to the ground, leaving your roof susceptible to the elements and creating leaks.

As a general rule, you should have about a 10-foot radius around your house thats clear of any branches. You should also go around and inspect any nearby trees for signs of rot or decay, as dead limbs are more likely to fall or break.

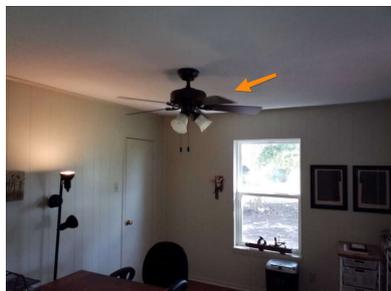
2: Light Inoperable

One or more lights are not operating. New light bulb possibly needed.

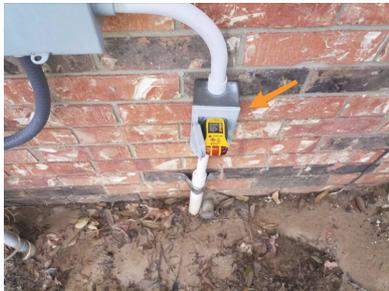
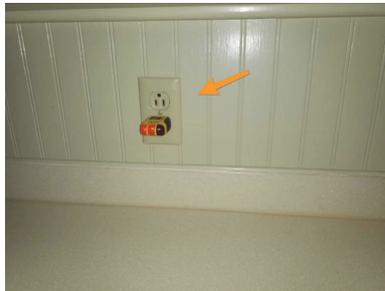
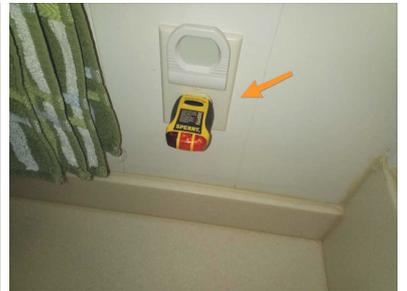
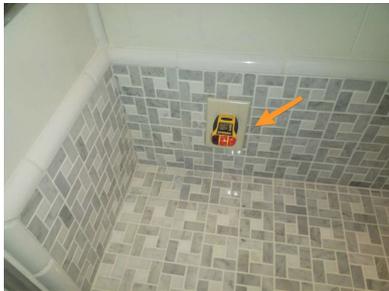
3: No GFCI Protection

No GFCI protection present . Recommend licensed electrician upgrade by installing ground fault receptacles in all wet locations.

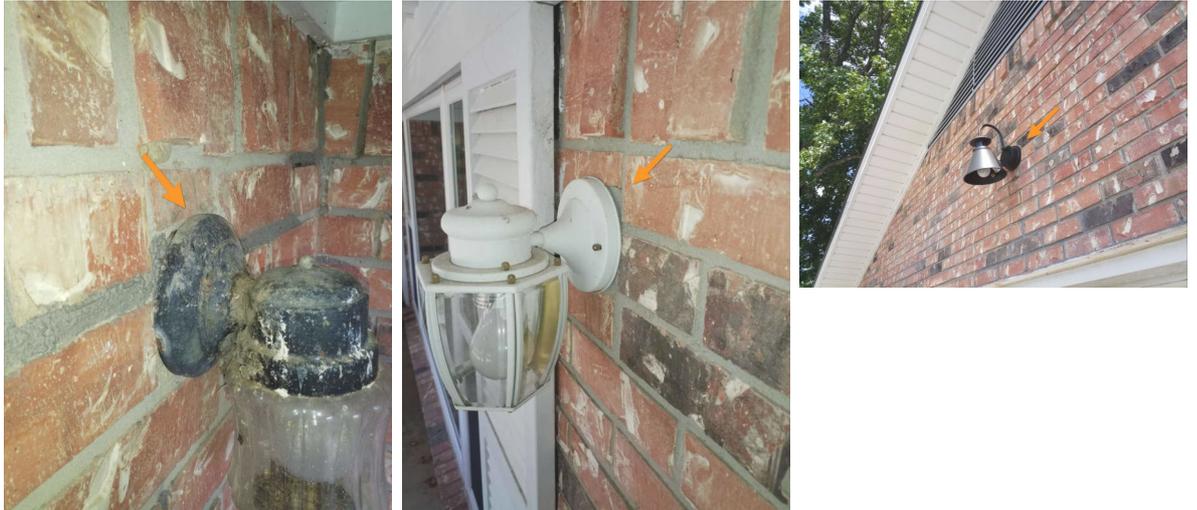
1: Sealant Recommend

Sealant Recommend around exterior light fixtures to prevent water intrusion and water contact with electrical

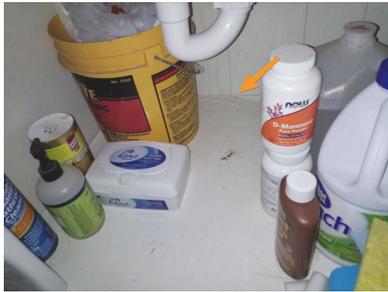
1: Floor damage under sink
➔ Deficient

Floor is damaged under sink.

Recommendation: Contact a qualified professional.

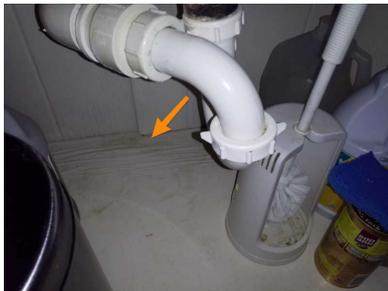
1: Damaged Floor Under Sink
➔ Deficient

Floor under sick is damaged.

Recommendation: Contact a qualified flooring contractor

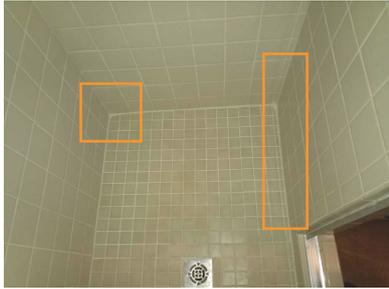
2: Sealant Needed
➔ Deficient

Sealant around tub and tile needs to be repaired or replaced.

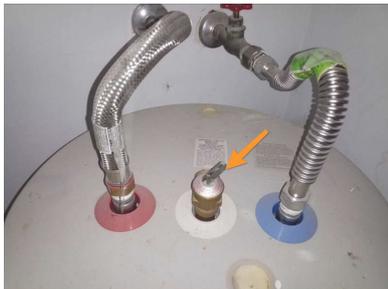
1: No discharge Piping

The discharge piping serving a pressure relief valve, temperature relief valve or combination thereof shall:

1. Not be directly connected to the drainage system.
2. Discharge through an air gap located in the same room as the water heater.
3. Not be smaller than the diameter of the outlet of the valve served and shall discharge full size to the air gap.

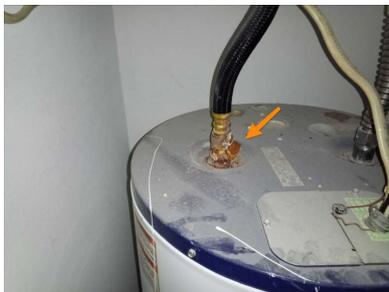
1: Corrosion at connection

Corrosion at water connection to water heater. Recommend replacing before it becomes an issue or leak.

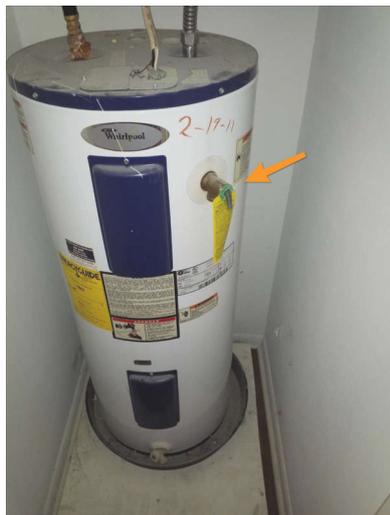
2: No discharge Piping

The discharge piping serving a pressure relief valve, temperature relief valve or combination thereof shall:

1. Not be directly connected to the drainage system.
2. Discharge through an air gap located in the same room as the water heater.
3. Not be smaller than the diameter of the outlet of the valve served and shall discharge full size to the air gap.
